**2007 Operations, Maintenance,
and Monitoring Report**

**Mandalay Bank Protection
Demonstration**

State Project Number TE-41
Priority Project List 9

August 2007
Terrebonne Parish

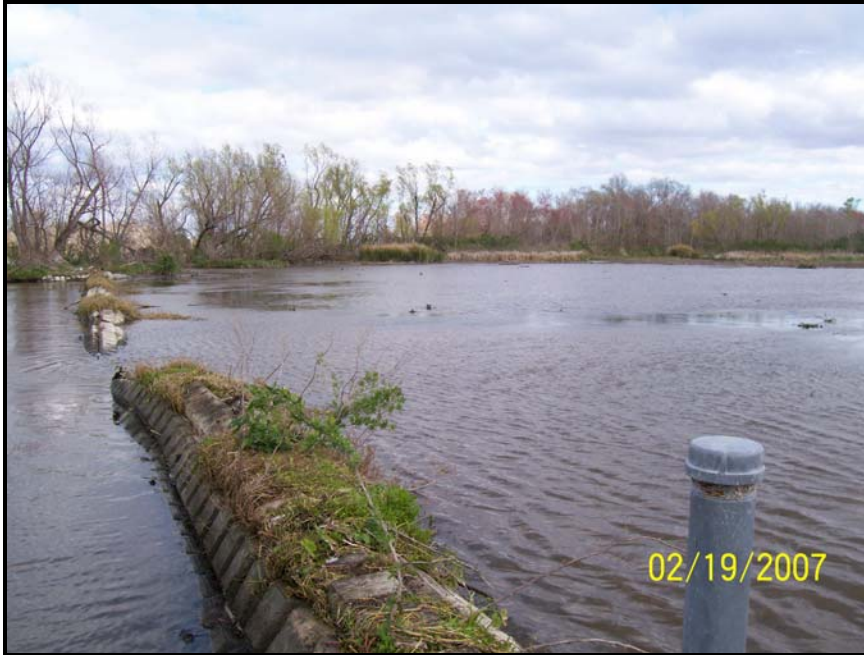
At Sites R1 and R2, increased settlement has occurred in two locations along the revetment mat / pipe system at each site. At Site R1, the two low areas are located approximately 40 ft east of the settlement plate and near the west end. At the time of inspection the water depth above the top of the mats at the east low area was approximately 0.3 ft. At Site R2, the two low areas are located approximately 25 ft east of the settlement plate and near the west end. At the time of inspection the water depth above the top of the mats at the two low areas was approximately 0.1 ft. It should be noted that in these locations of observed settlement at Sites R1 and R2, fill material had to be placed in order to level the bottom before placement of the fabric, pipe, and mats during construction. No noticeable damage to the structures was apparent. The settlement plate riser pipes appeared to be in good condition. While the settlement plate riser pipe at Site R3 is visually out of plumb, this riser pipe was leaning upon installation. The warning signs and support piles at the three sites were in excellent condition. The bank tie-ins were in good condition with some bank erosion noted. Overall, the revetment mat structures appear to be intact and do not require any maintenance (Appendix B, Photos 1 – 15).

Photo 1. *Site R1 –
View along revetment
mat system looking
east.*

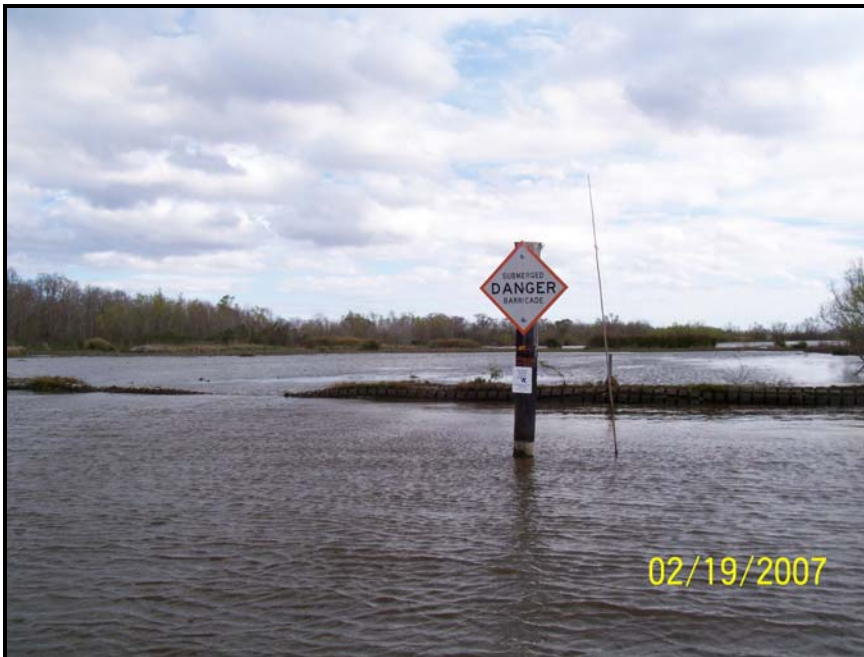
Photo 2. *Site R1 –
View of warning sign
and settlement plate
riser pipe looking south
from GIWW.*

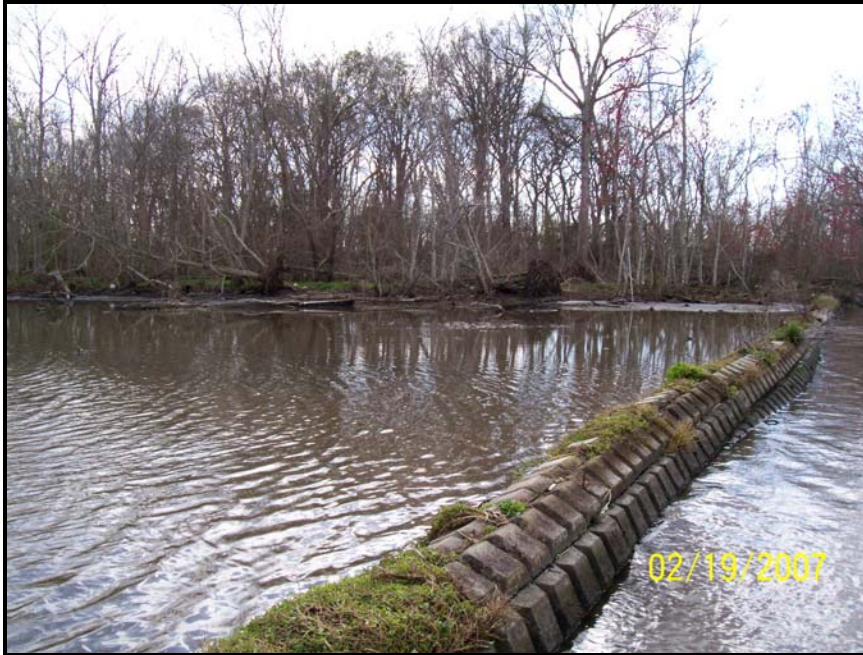
Photo 3. *Site R1 –
View along revetment
mat system looking
west.*

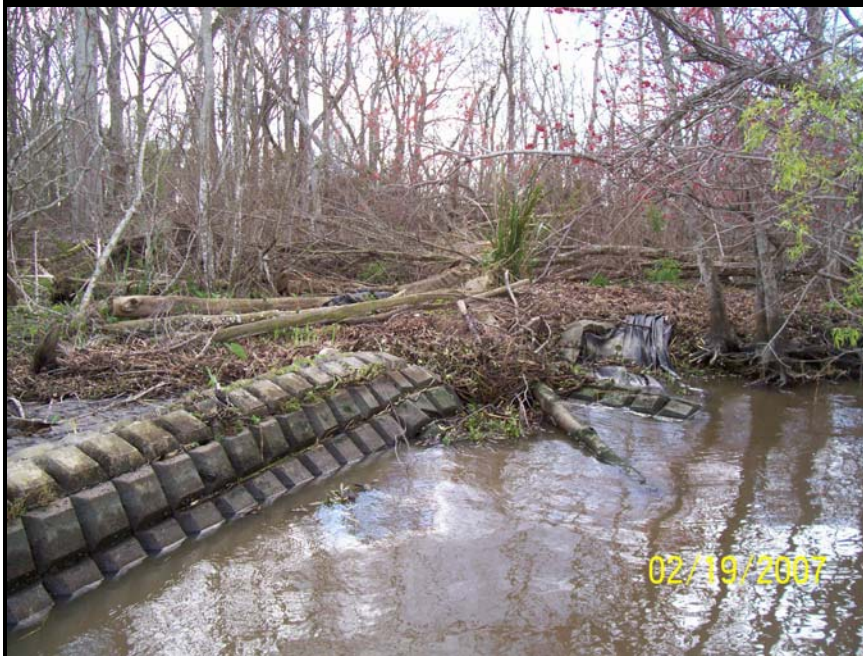
Photo 4. *Site R1 –
View of west bank tie-
in.*

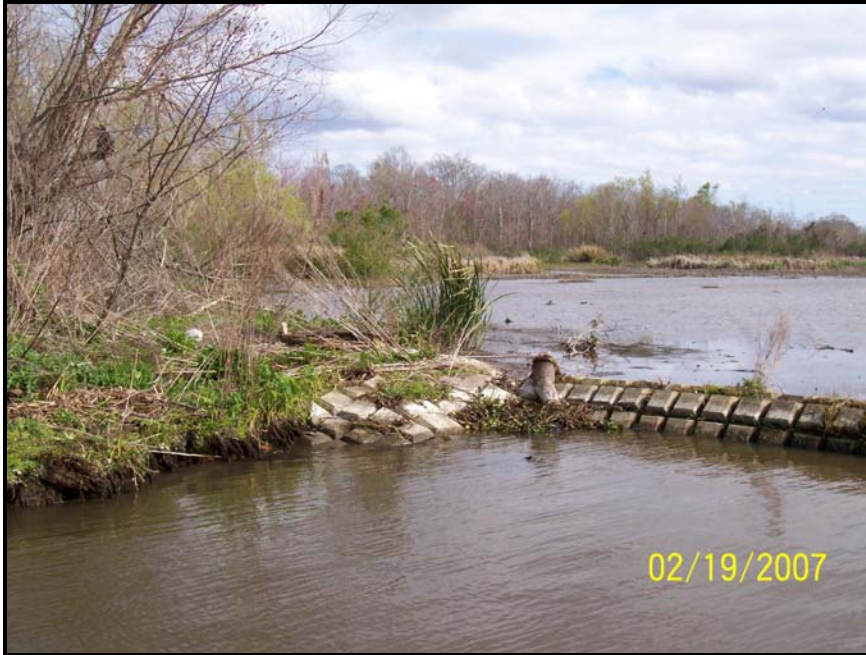
Photo 5. *Site R1 –
View of east bank tie-
in.*

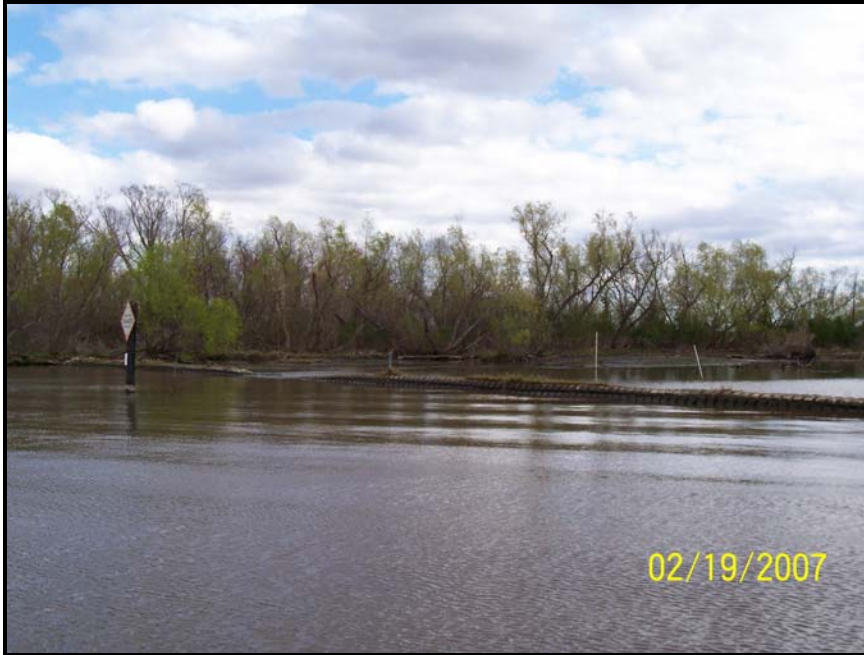
Photo 7. *Site R2 –
View of revetment mat
system looking
southeast.*

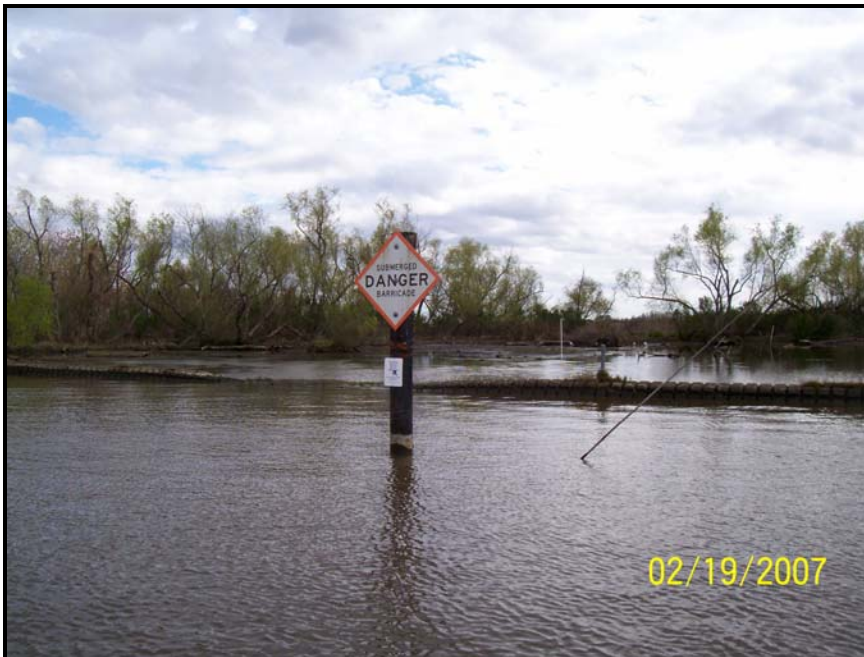
Photo 8. *Site R2 –
View of warning sign
and settlement plate
riser pipe looking south
from GIWW.*

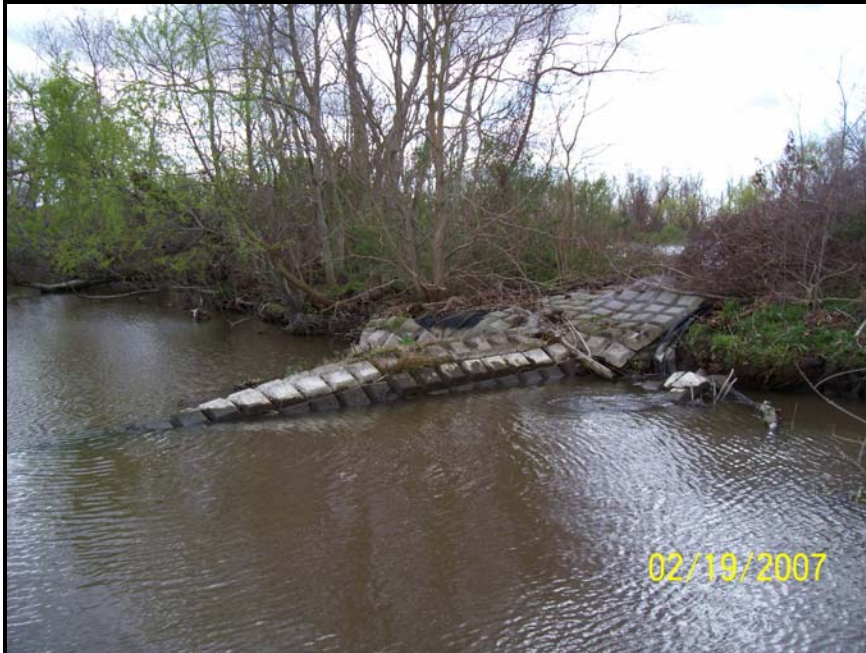
Photo 9. *Site R2 –
View of west bank tie-
in.*

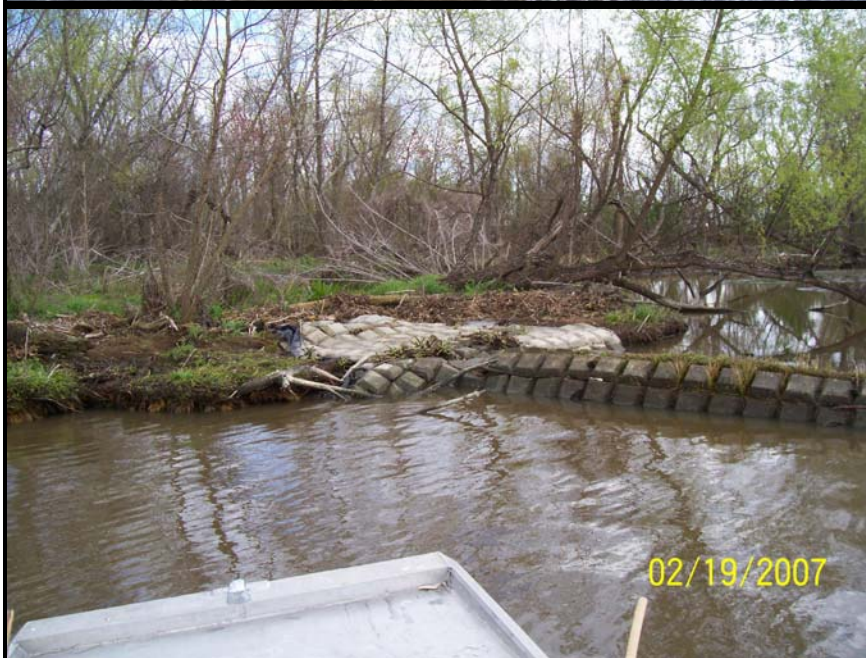
Photo 10. *Site R2 –
View of east bank tie-
in.*

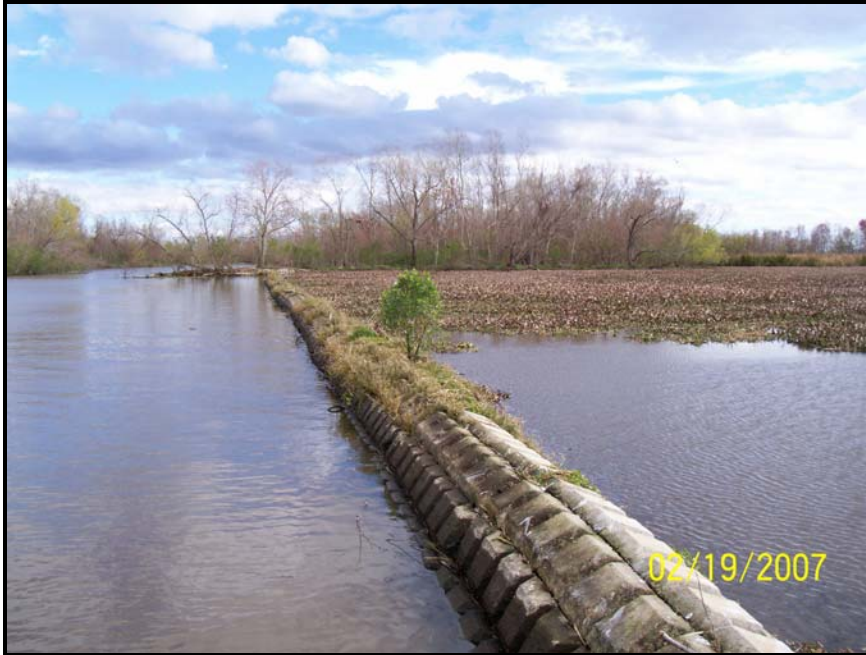
Photo 11. *Site R3 – View along revetment mat system looking east.*

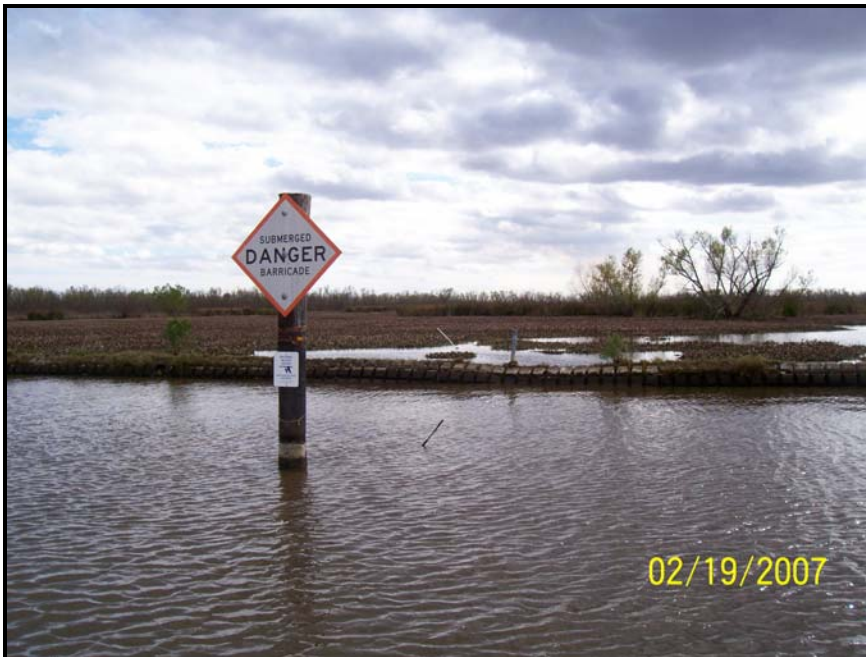
Photo 12. *Site R3 – View of warning sign and settlement plate riser pipe looking south from GIWW.*

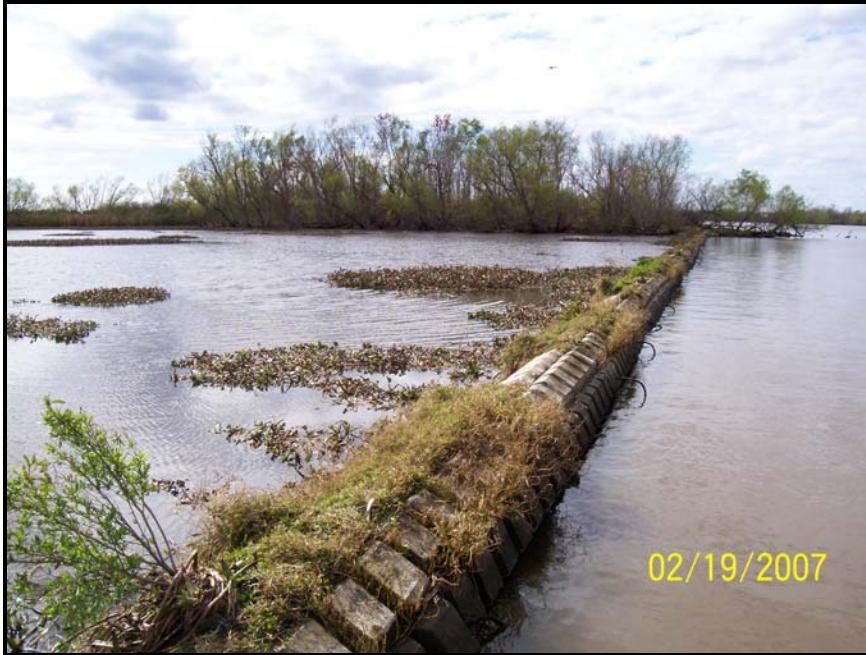
Photo 13. *Site R3 –
View along revetment
mat system looking
west.*

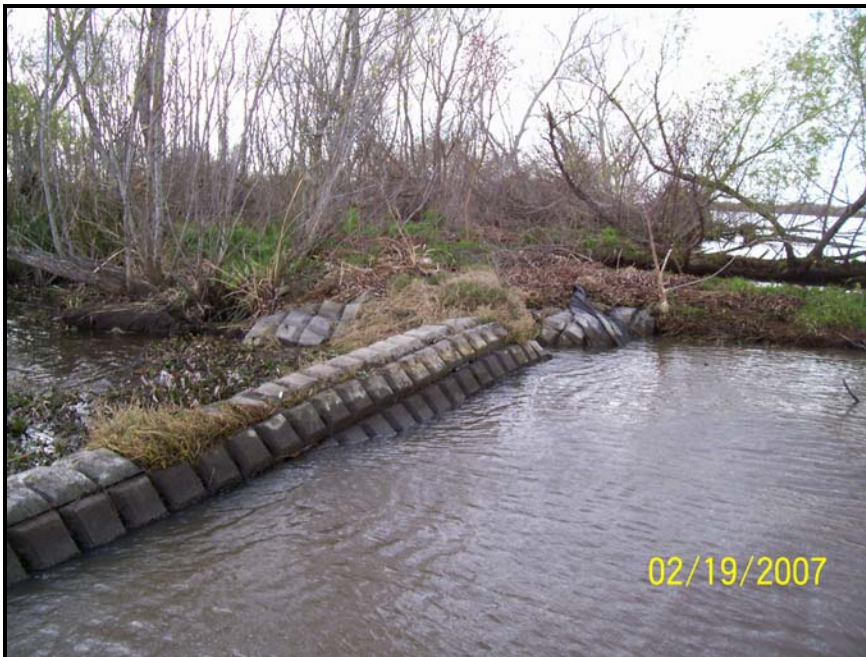
Photo 14. *Site R3 –
View of west bank tie-
in.*

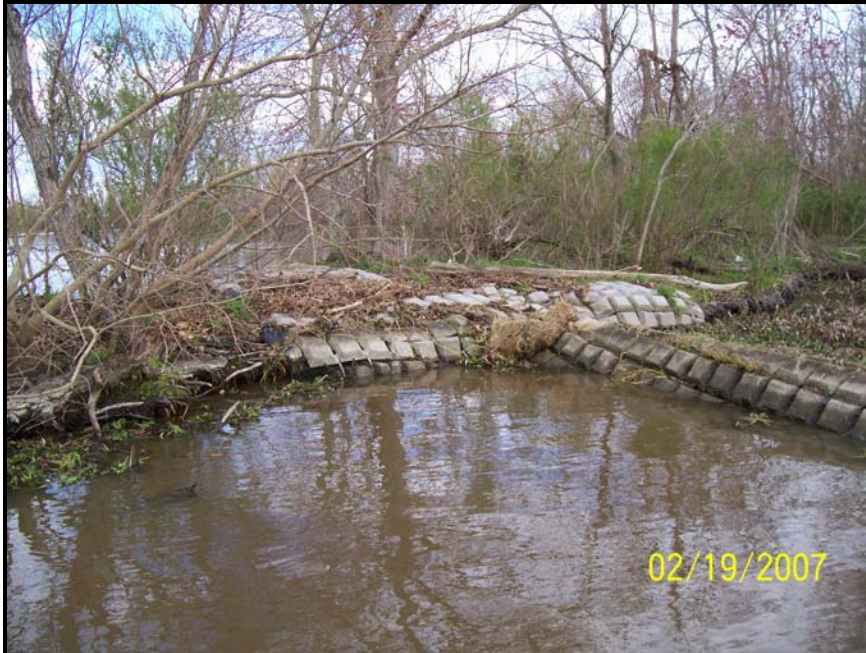
Photo 15. *Site R3 –
View of east bank tie-
in.*

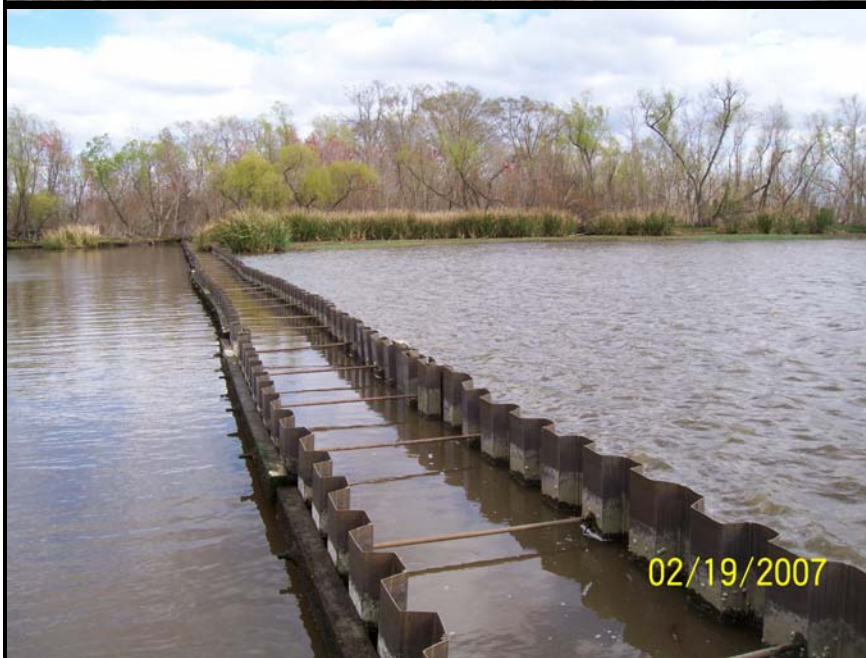
During the inspection, water levels were such that the sheet pile structures were exposed to the bottom of the timber walers. No noticeable breaching or major damage to the structures was apparent. Some minor cracks, splits, and missing tops of sheet pile above the timber waler were observed. Timber walers appeared to be in good condition at all three sites. The galvanized tie rods and timber waler hardware were in good condition with only a minimal amount of corrosion present. The warning signs and support piles were in excellent condition. The bank tie-ins appeared to be in good condition. Overall, the sheet pile structures appear to be intact and do not require any maintenance (Appendix B, Photos 16 – 30).

Photo 16. *Site V1 –
View of fiberglass sheet
pile system looking
east.*

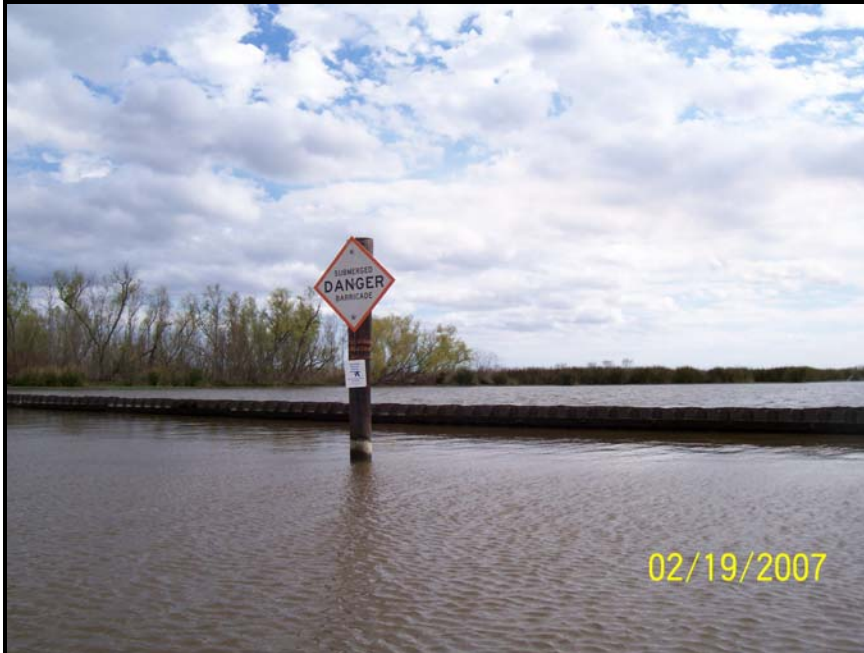
Photo 17. *Site V1 – View of warning sign looking south from GIWW.*

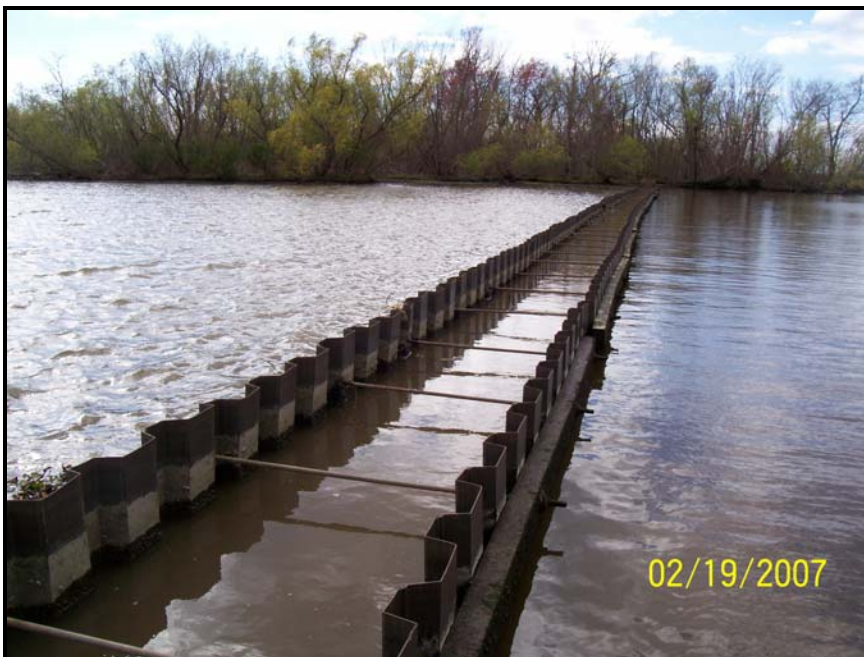
Photo 18. *Site V1 – View of fiberglass sheet pile system looking west.*

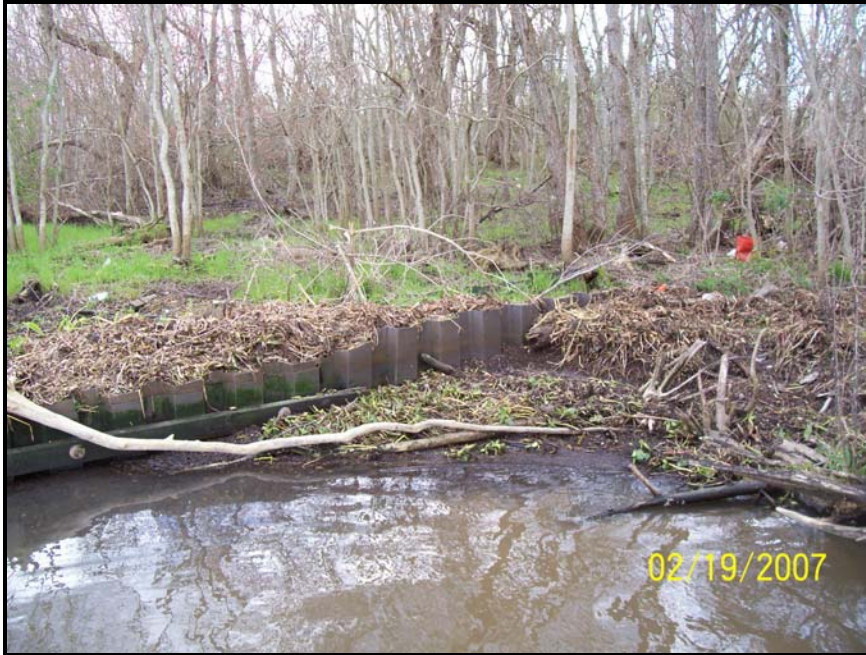
Photo 19. *Site V1 –
View of west bank tie-
in.*

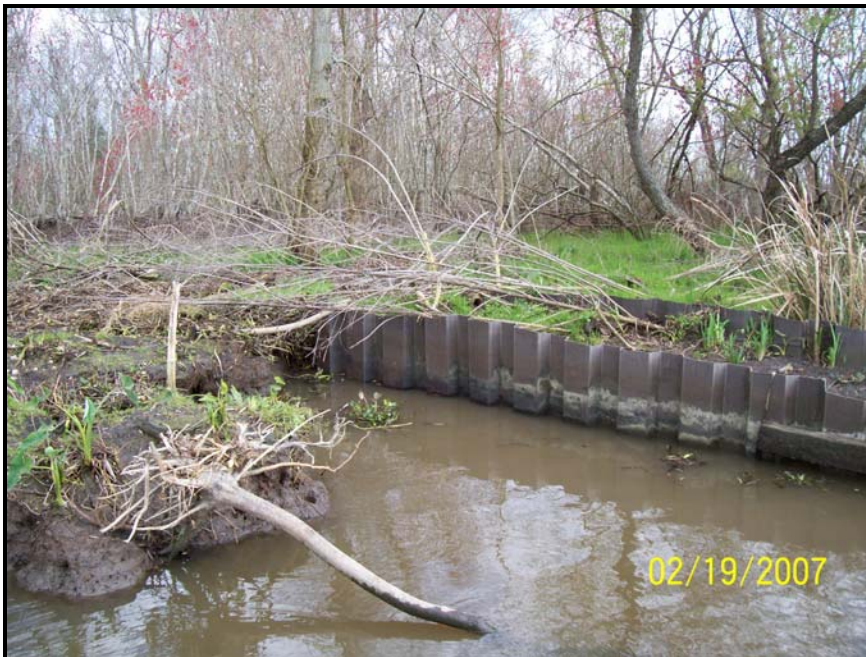
Photo 20. *Site V1 –
View of east bank tie-
in.*

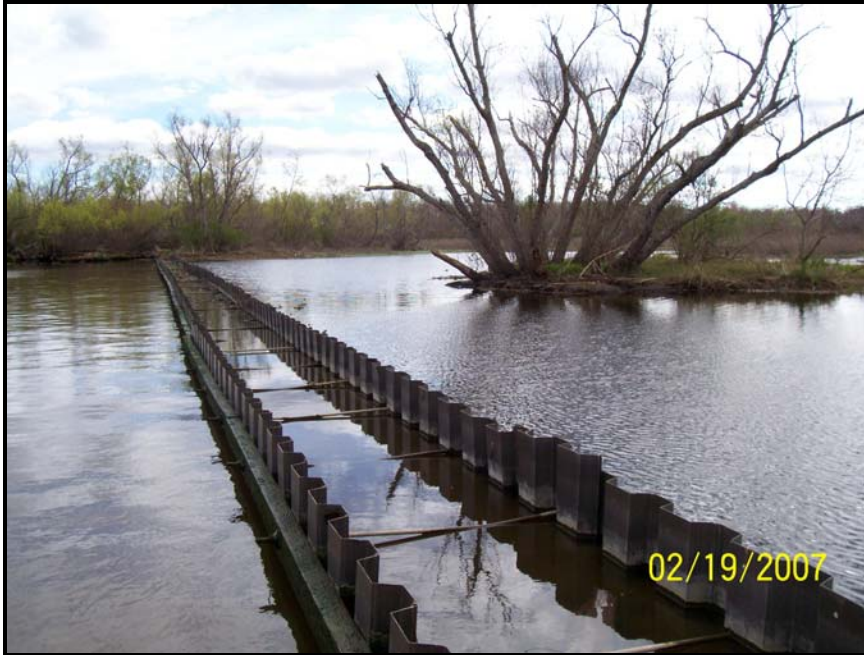
Photo 21. Site V2 –
View of fiberglass sheet
pile system looking
east.

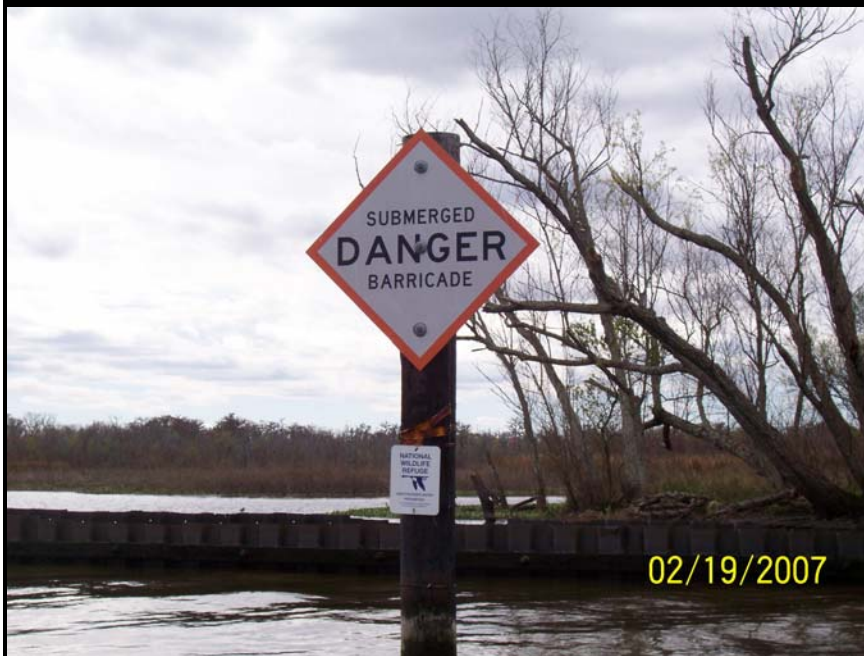
Photo 22. Site V2 –
View of warning sign
looking south from
GIWW.

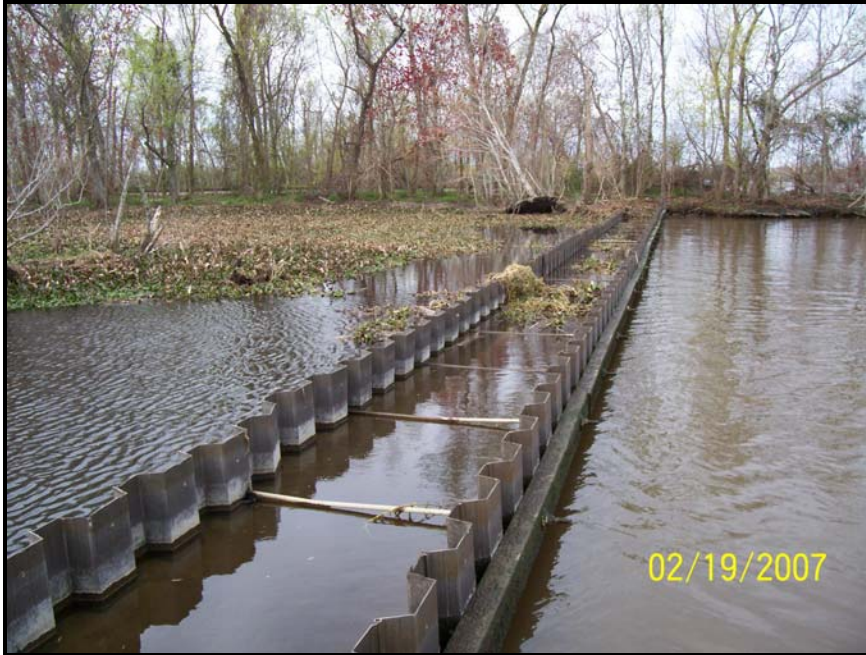
Photo 23. Site V2 –
View of fiberglass sheet
pile system looking
west.

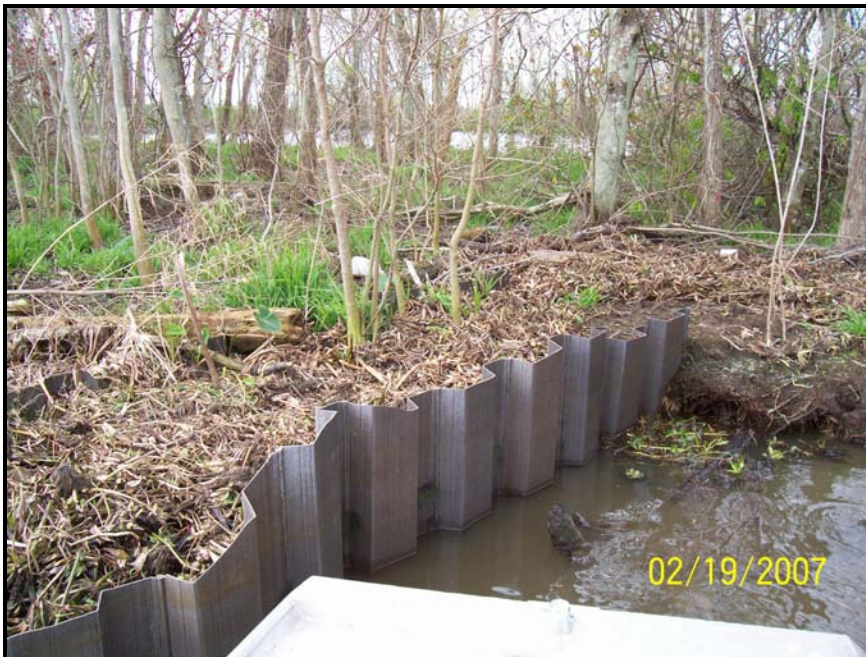
Photo 24. Site V2 –
View of west bank tie-
in.

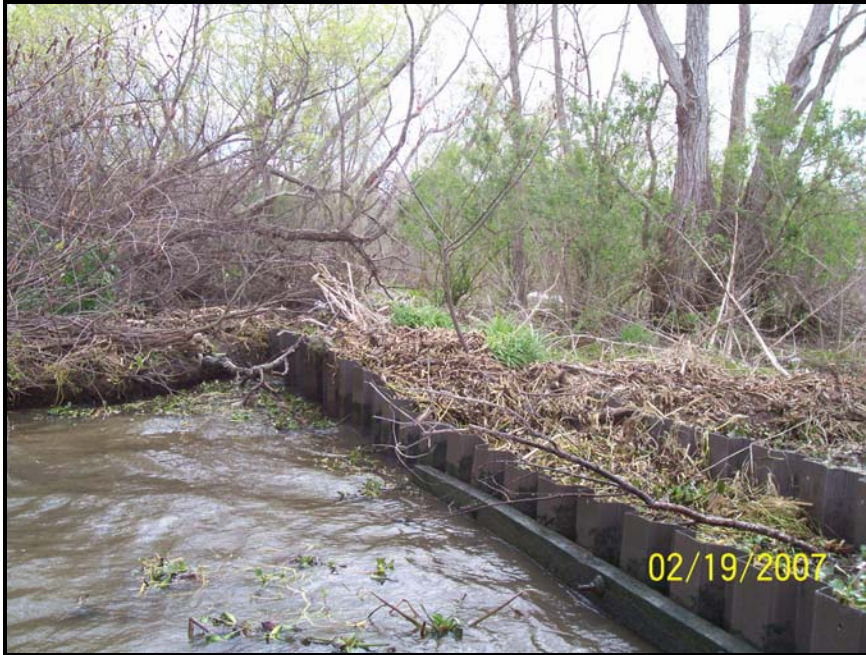
Photo 25. *Site V2 –
View of east bank tie-
in.*

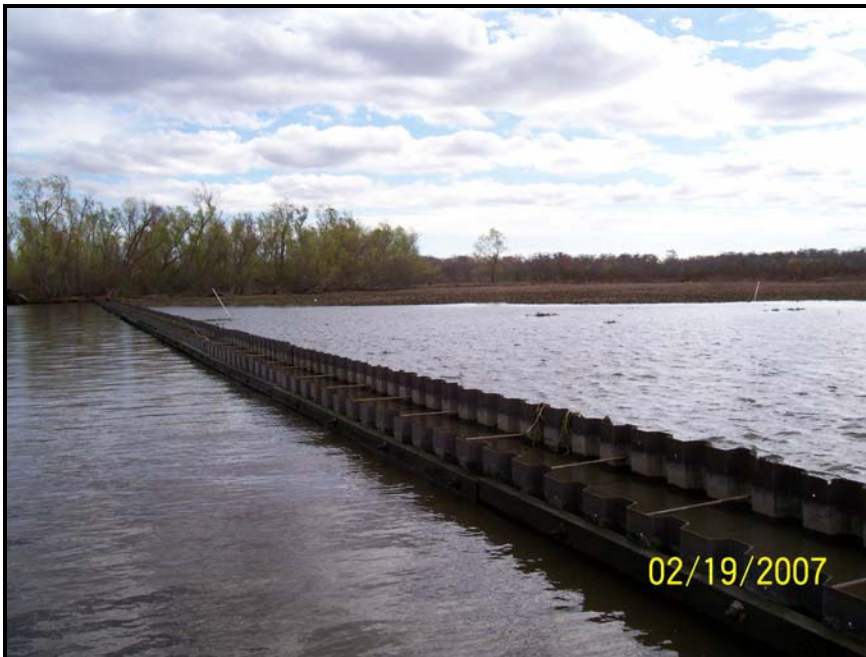
Photo 26. *Site V3 –
View of fiberglass sheet
pile system looking
east.*

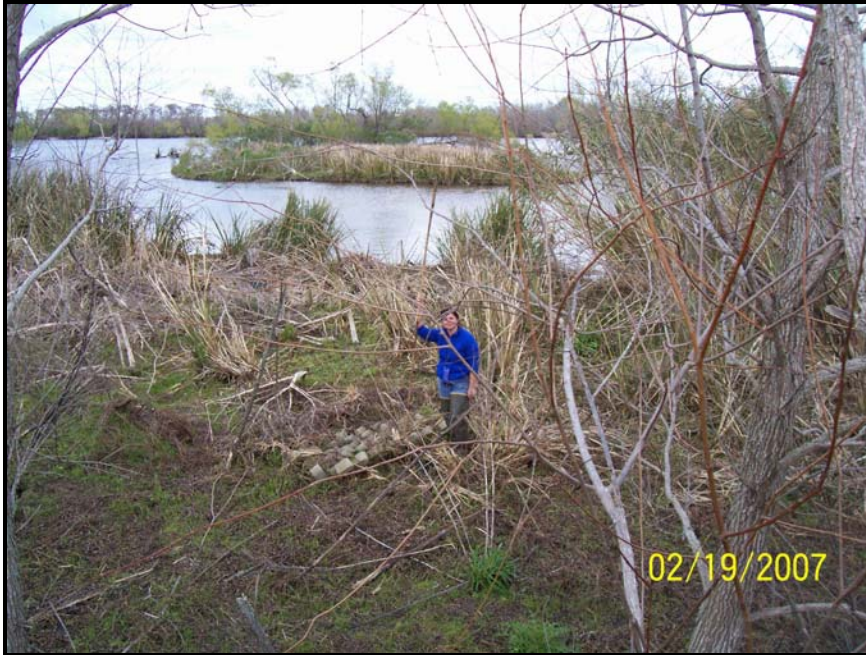
At the adjacent Sites J1 and J2, accretion has occurred, and the A-Jacks® (double row) are now covered by well-vegetated, accumulated material. The depth of cover over the A-Jacks® was found to be 1 ft to 2 ft in some locations. The extent of vegetated accretion appears to be greater than 200 ft in some locations as it extends from the old shoreline behind the A-Jacks® northward toward the GIWW beyond the warning signs at the two sites. Survival of the plantings at J1 and J2 appears to be significantly less than was observed during the 2005 inspection. Some groups were noted that may still be dormant from the winter. Also, it appears that some plantings have been transplanted, possibly by the hurricanes of 2005. At Site J3, the water level was just below the tops of the A-Jacks®. No accretion has occurred except at the west tie-in where the structure ties into the Site A2 plug. In fact, it appears as if the shoreline may have continued to experience some measure of erosion at this site. The survival rate of the plantings at Site J3 still appears to be the lowest (out of the three sites) as noted in the 2005 inspection report. The tie-ins appeared to be in good condition at the three sites. The warning signs and support piles at the three sites were in excellent condition. No maintenance is recommended for the concrete armor unit sites at this time (Appendix B, Photos 31 – 41).

Photo 36. Site J2 –
View of accretion and
vegetation in front of
warning sign looking
east.

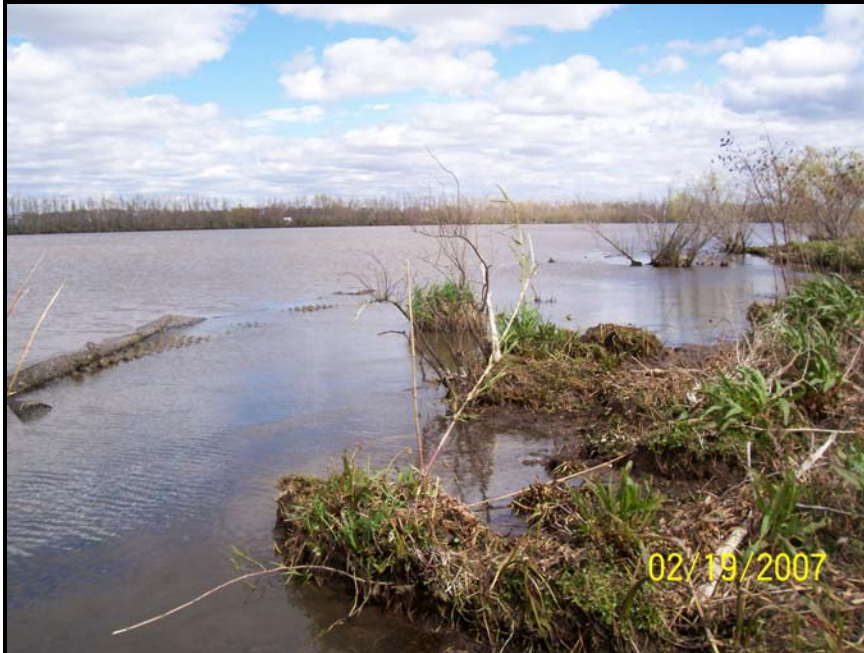
Photo 38. *Site J3 –
View of west bank tie-in
(covered by accreted
material).*

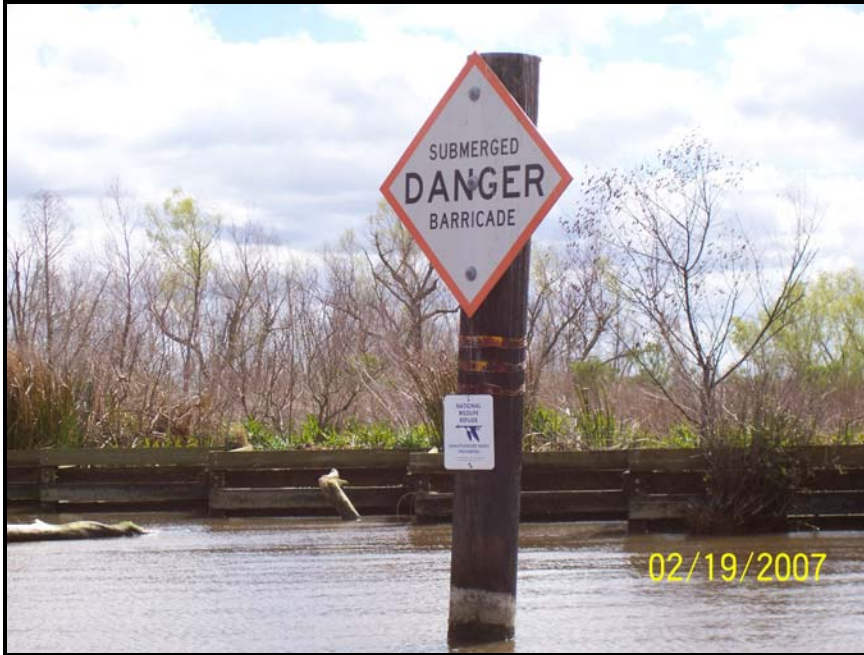
This fence site is adjacent to plug Site A2 where extensive accretion of material has occurred. In some locations material has accreted greater than 50 ft from the old shoreline behind the fence out to the warning sign. In the vertical direction the material has reached the second timber on the fence or higher. The plantings' survival rate at Site F3 appears to have drastically reduced from that noted in the 2005 inspection. As noted in the 2005 inspection, the survival rates of the planted giant cutgrass associated with Sites F1 and F2 appeared to still be very low. At Site F2, the identified maintenance needs were the leaning warning sign at Site F2 and the damaged fence sections. No maintenance funds are provided for the repair of any project features, so no maintenance will be performed on the fence. However, the damage to these sections as well as the length of time since the occurrence should be noted in the demonstration project results (Appendix B, Photos 42 – 54).

Photo 42. *Site F1 –
View of timber fencing
and plantings looking
east.*

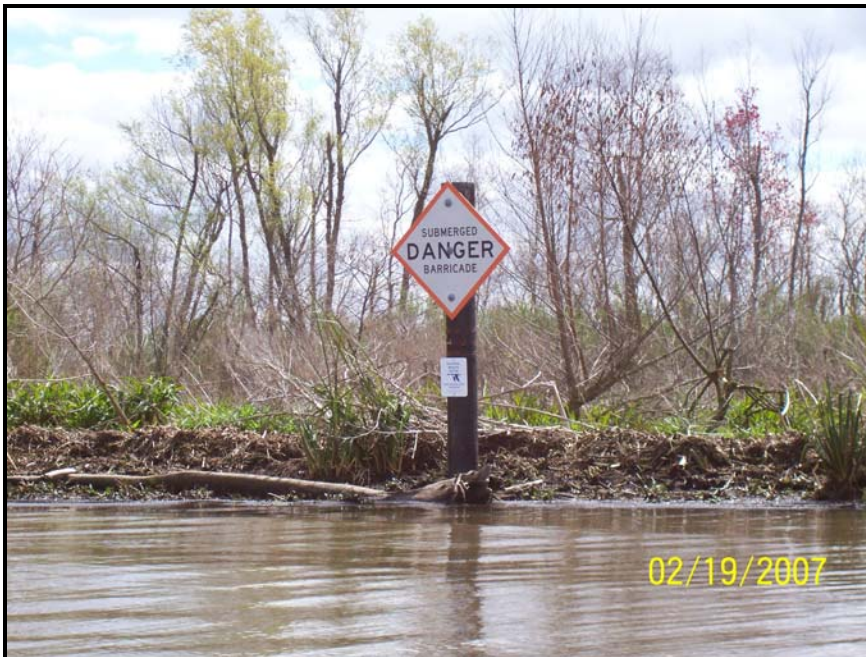
The concrete revetment mats appeared to be in good condition. Material has accreted in front of sites A1 and A2. The most accretion has occurred at Site A2 where the extent of vegetated accretion reaches well beyond the warning sign. The bank tie-ins were also in good condition. The warning signs and support piles were in excellent condition. Overall, the armored plugs appear to be intact and do not require any maintenance (Appendix B, Photos 55 – 66).

Photo 55. Site A1 –
View of armored plug
standing on top of plug
looking east.

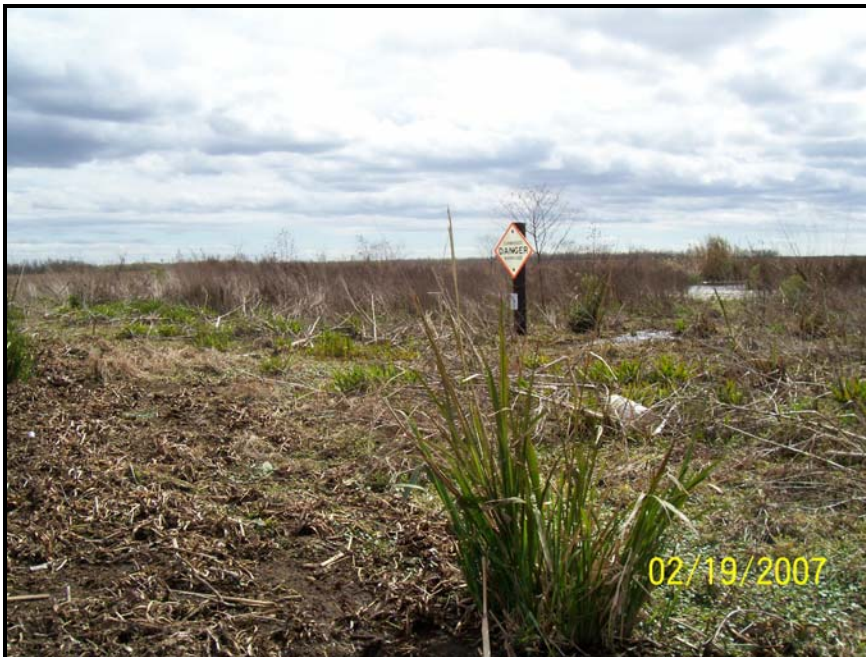
Photo 59. Site A2 –
View of armored plug
standing on top of plug
looking east.

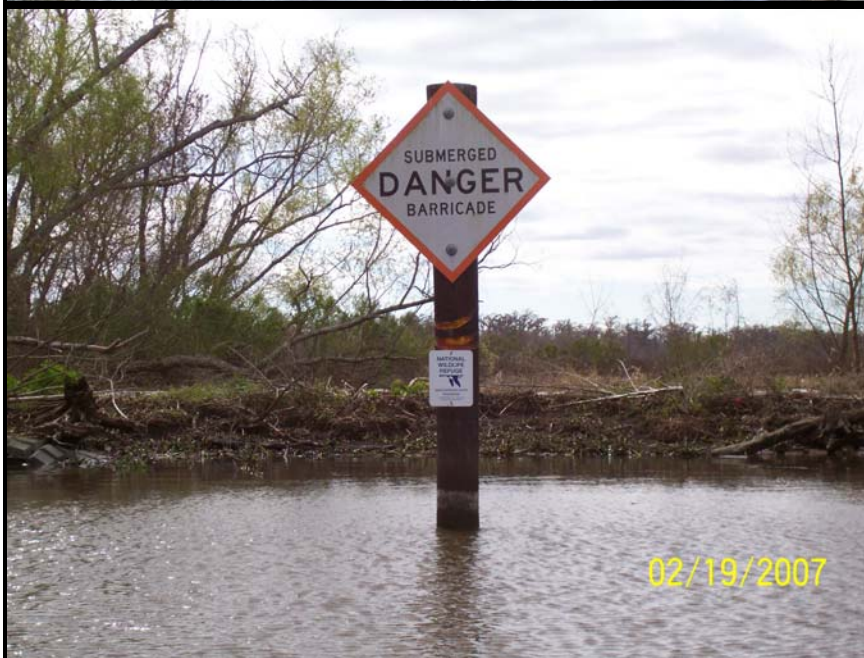
Photo 63. Site A3 –
View of armored plug
looking south east.
